SITE NAME: Chemetco**CERCLIS ID** ILD 048 843 809**COUNTY:** Madison**DATE:** 04/01/08**TIME:** 1100**PHOTO BY:**

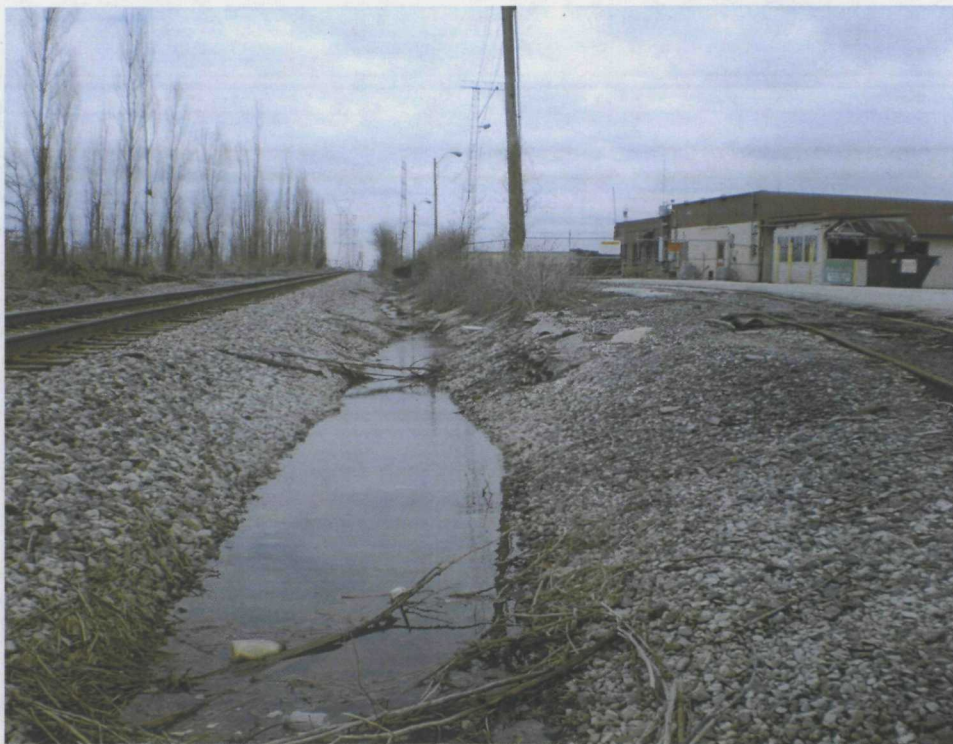
COMMENTS: Photo taken to the north of the ditch paralleling the rail road tracks and the west side of Chemetco. Surface water runoff from the site was flowing into the ditch.

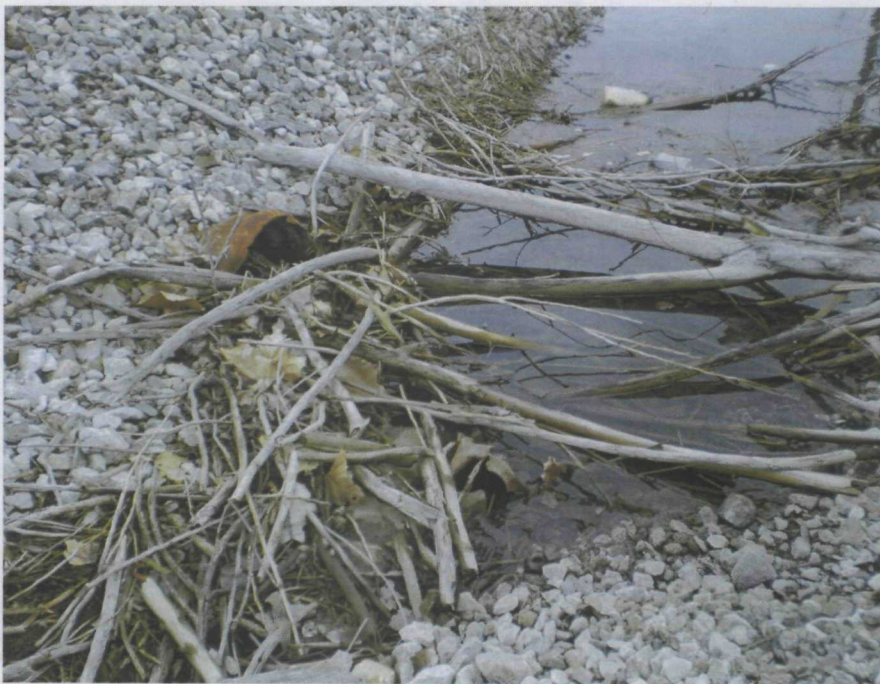
COMMENTS: Photo taken of the drainage ditch running parallel to the rail road tracks and on the west side of Chemetco. This photo was taken near the entrance road to Chemetco. A pipe was directing surface water under the rail road tracks.

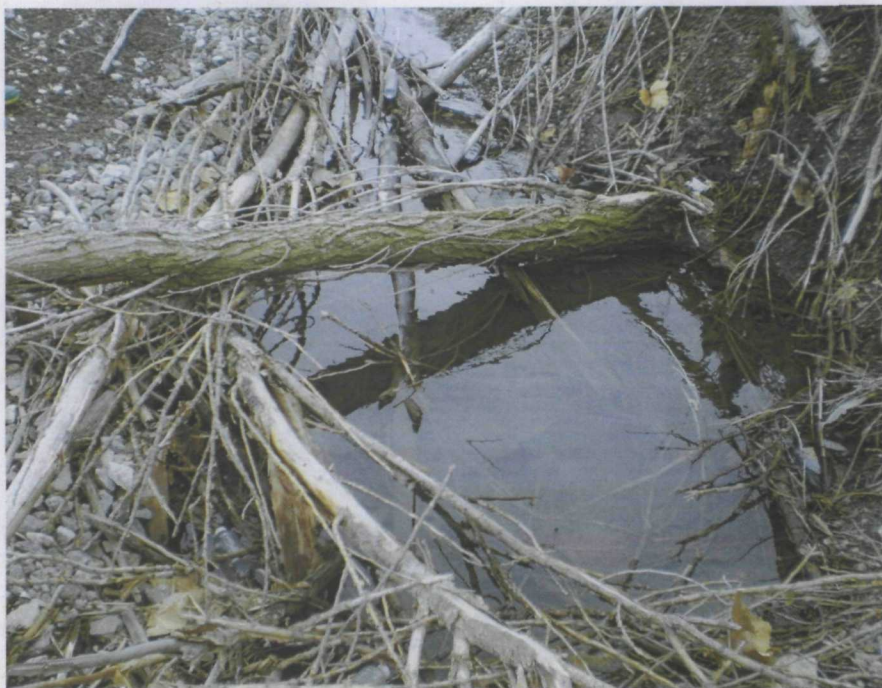
COMMENTS: Photo taken of water flowing from the east side of the railroad tracks to the west side of the rail road tracks by pipe.

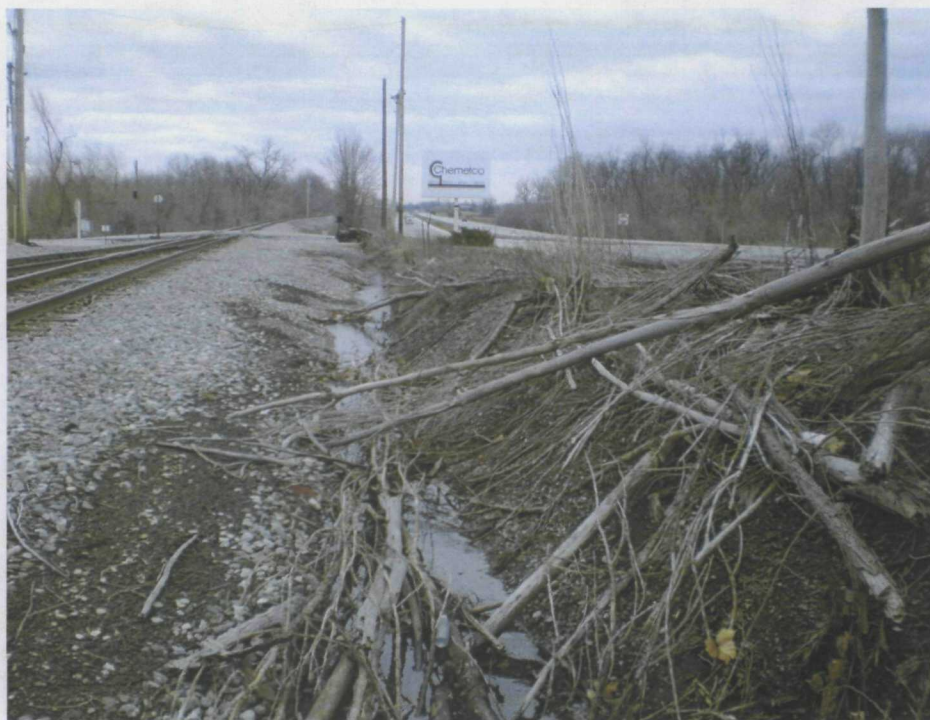
COMMENTS: Photo taken of surface water flowing on the west side of Chemetco and on the west side of the rail road tracks after traveling through pipe from east side of rail road tracks.

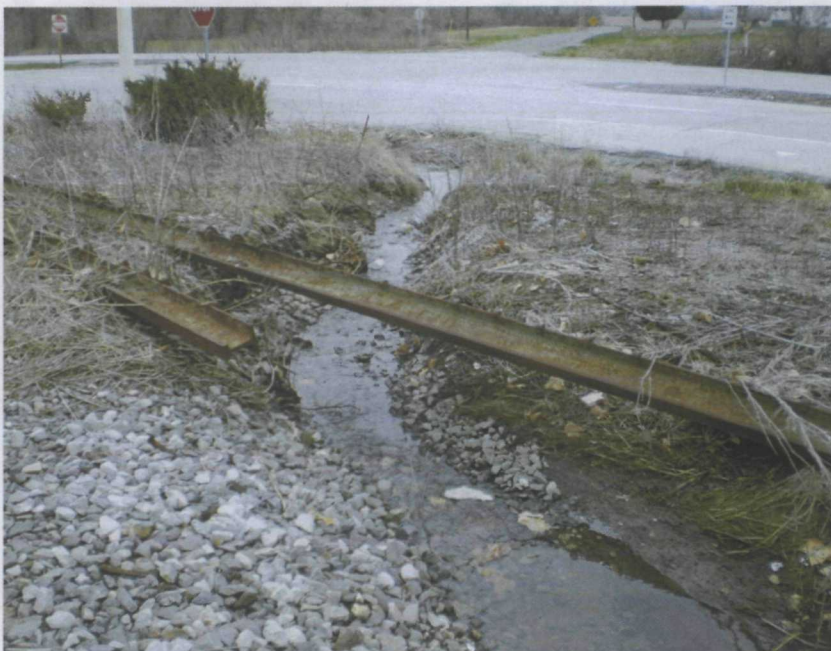
COMMENTS: Photo taken of the surface water on the west side of Chemetco and RR tracks from the pipe to the ditch paralleling Route 3. Notice Oldenburg Road in the background.

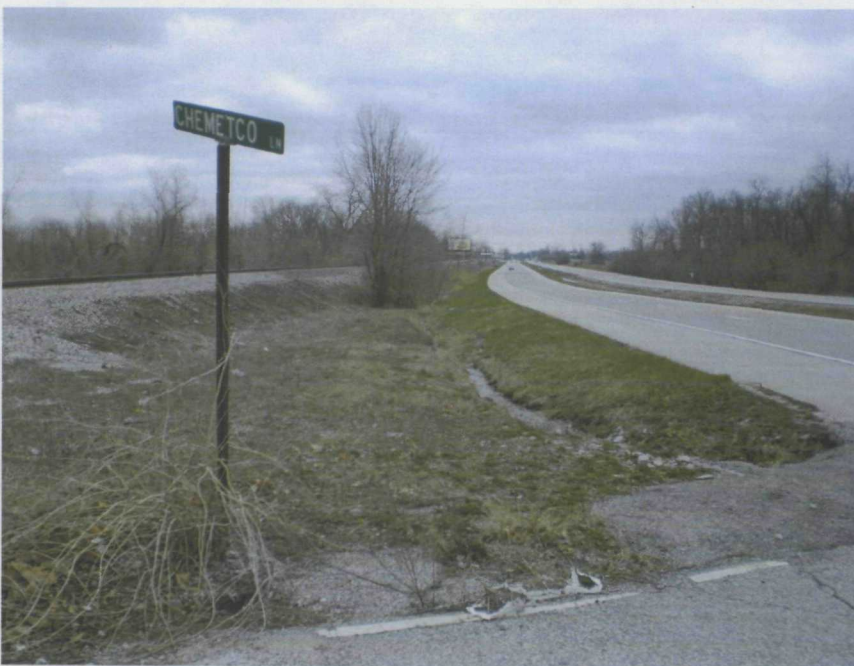
COMMENTS: Photo taken of the surface water as it travels under Chemetco Lane and flow south along the ditch paralleling Route 3.

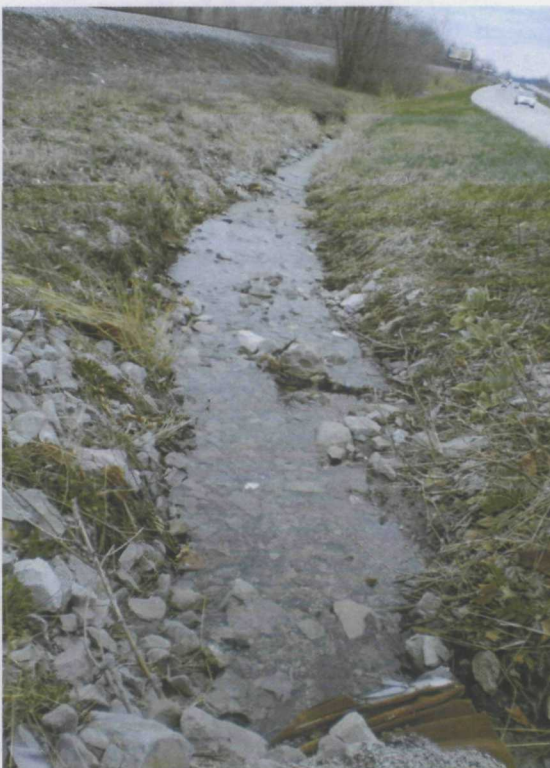
COMMENTS: Photo taken of surface water exiting the pipe directing water under Chemetco Lane.

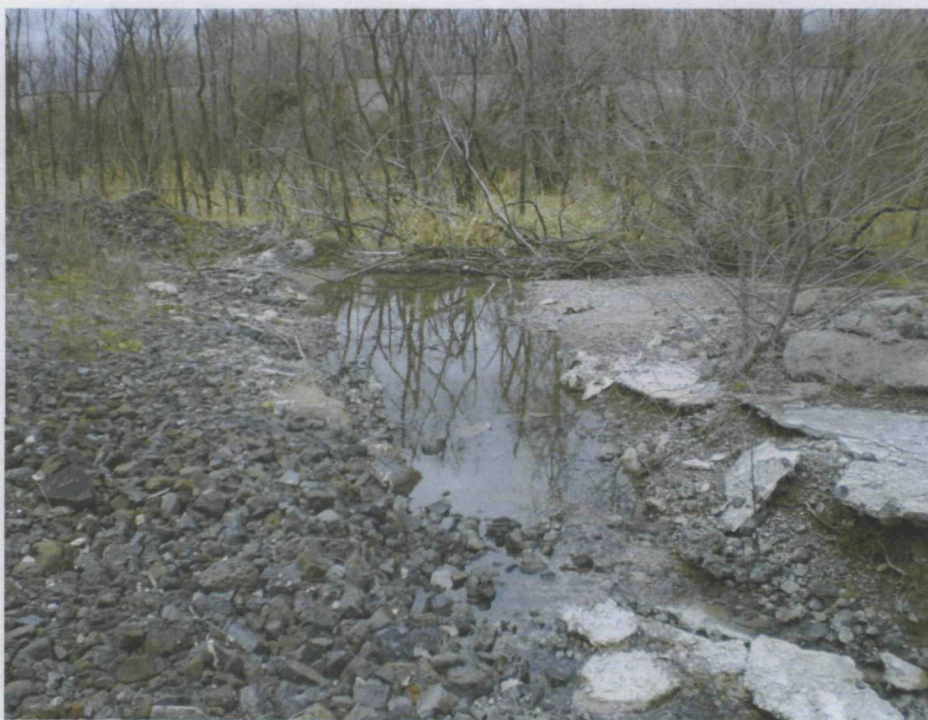
COMMENTS: Photo taken of the surface water as it leaves the slag parking area located to the south of Chemetco. This is near the southwest corner. Notice RR tracks in the background. Designated wetlands are in the trees and brown vegetation.

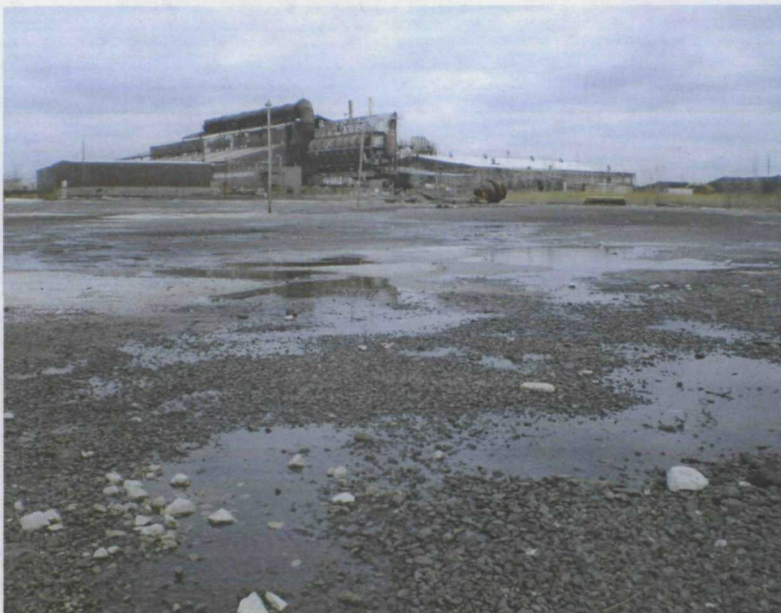
COMMENTS: Photo taken of the surface water flowing to the south through the slag parking lot from Chemetco.

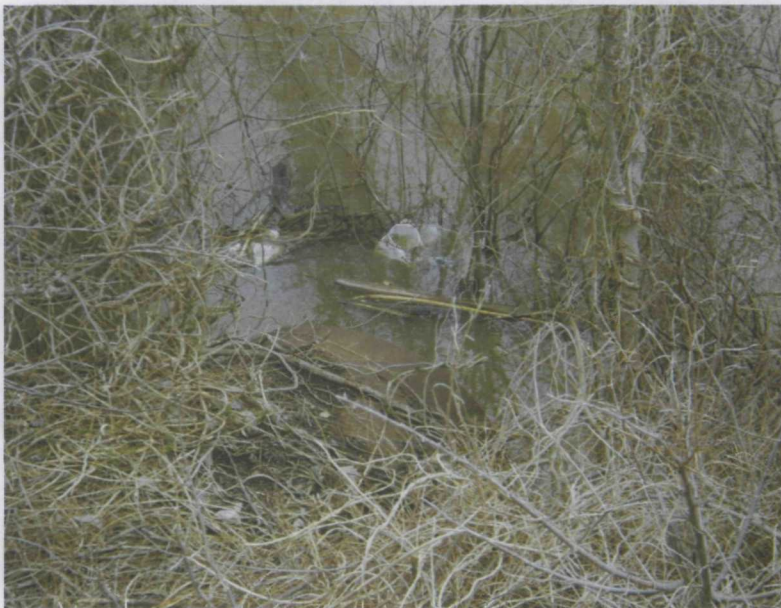
COMMENTS: Photo taken of the pipe directing surface water from the ditch parralleling Route 3 and RR tracks to the unnamed tributary of Long Lake.

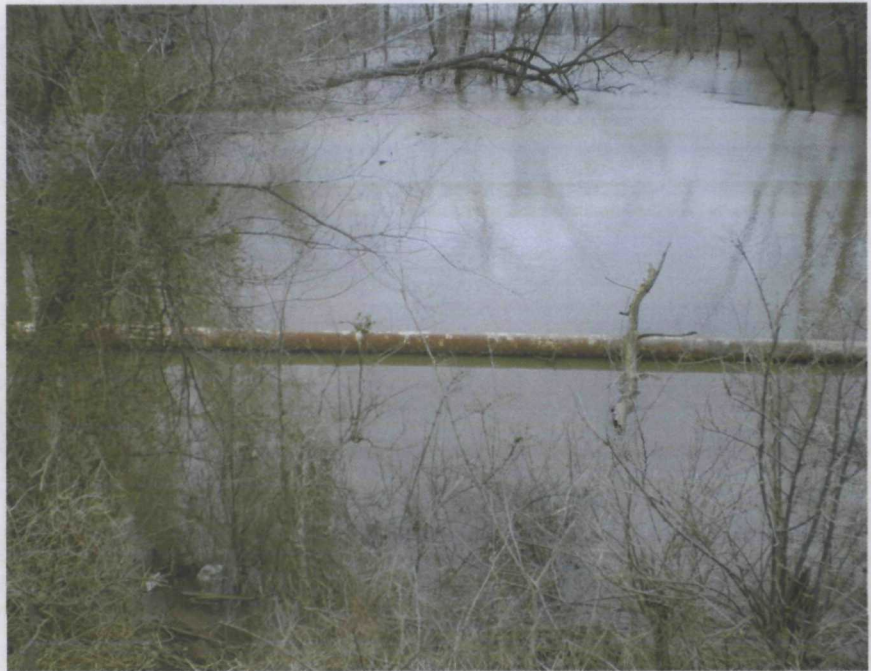
Expanded photo of the pipe (left hand corner) directing surface water to the unnamed tributary of Long Lake.

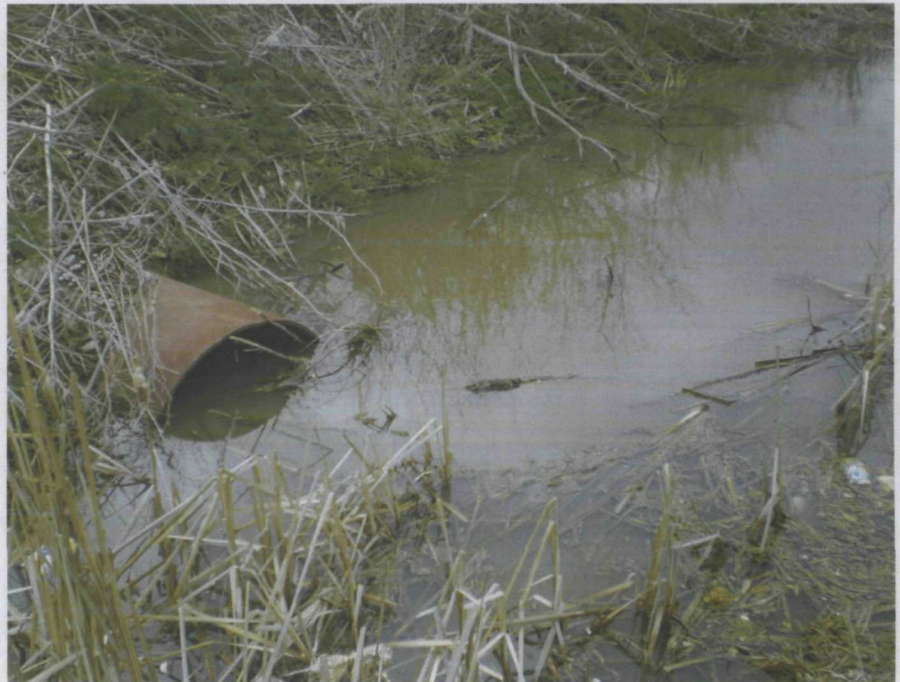
COMMENTS: Photo taken of the pipe directing water from the ditch to unnamed tributary of Long Lake.

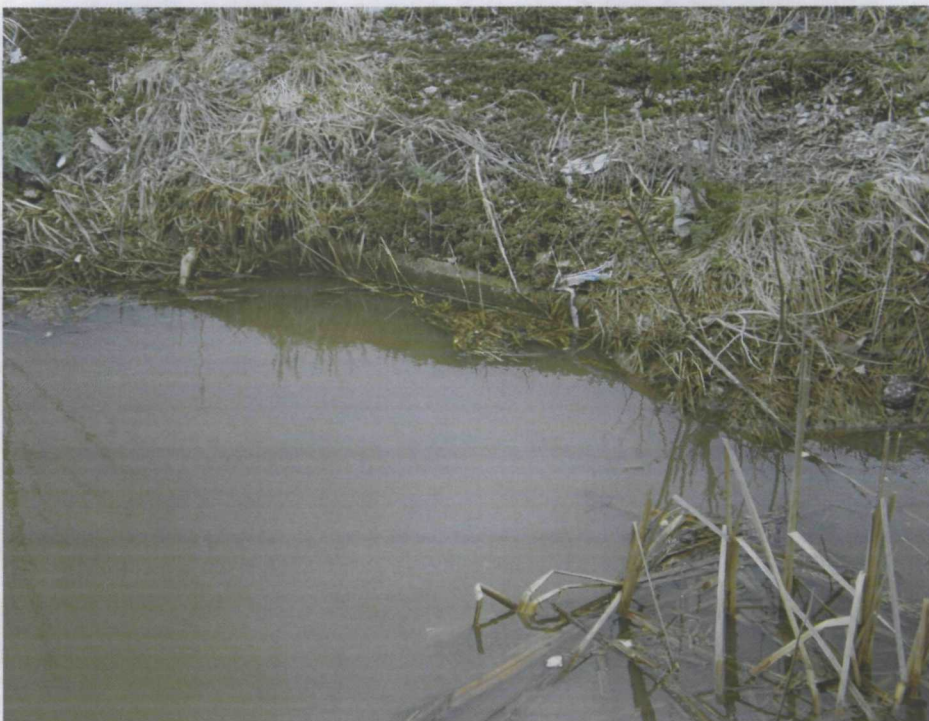
COMMENTS: Photo taken of a concrete conduit on the east side of Route 3. This conduit may connect the ditch on the west side of Route 3 with the surface water on the east side of Route 3.

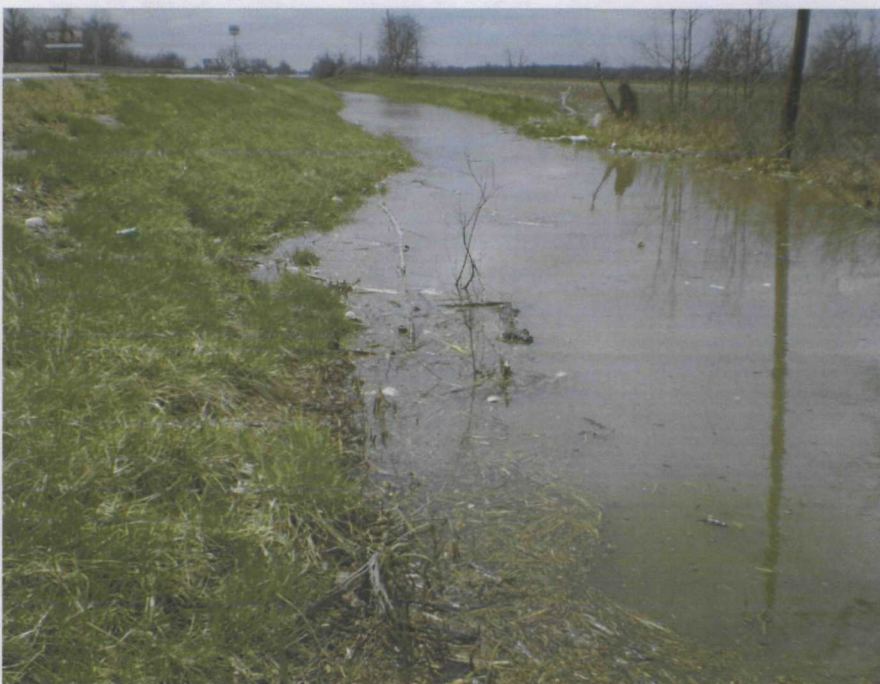
COMMENTS: Photo taken of the surface water located on the west side of Route 3.

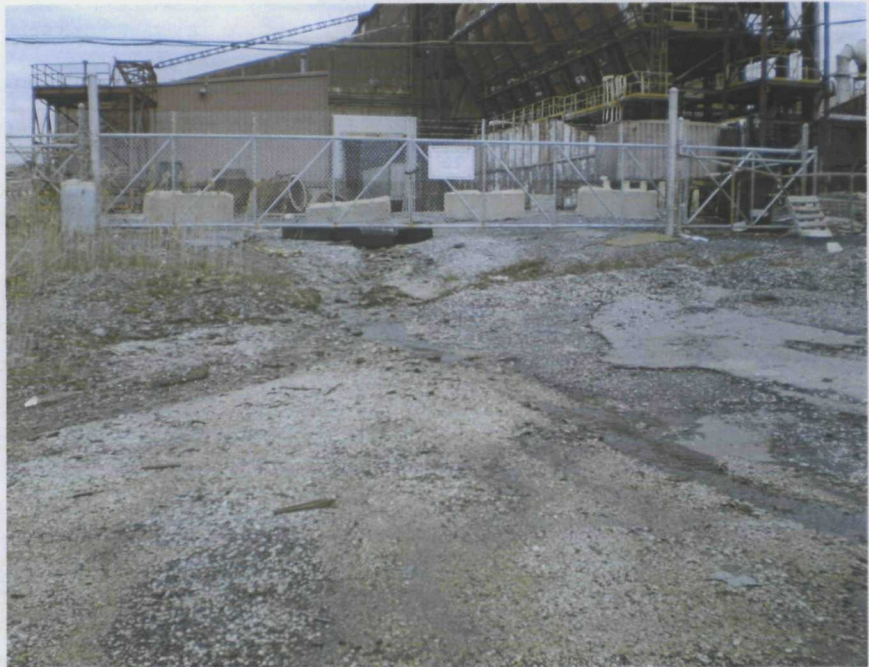
COMMENTS: Photo taken of surface water leaving the site on the south side of Chemetco.

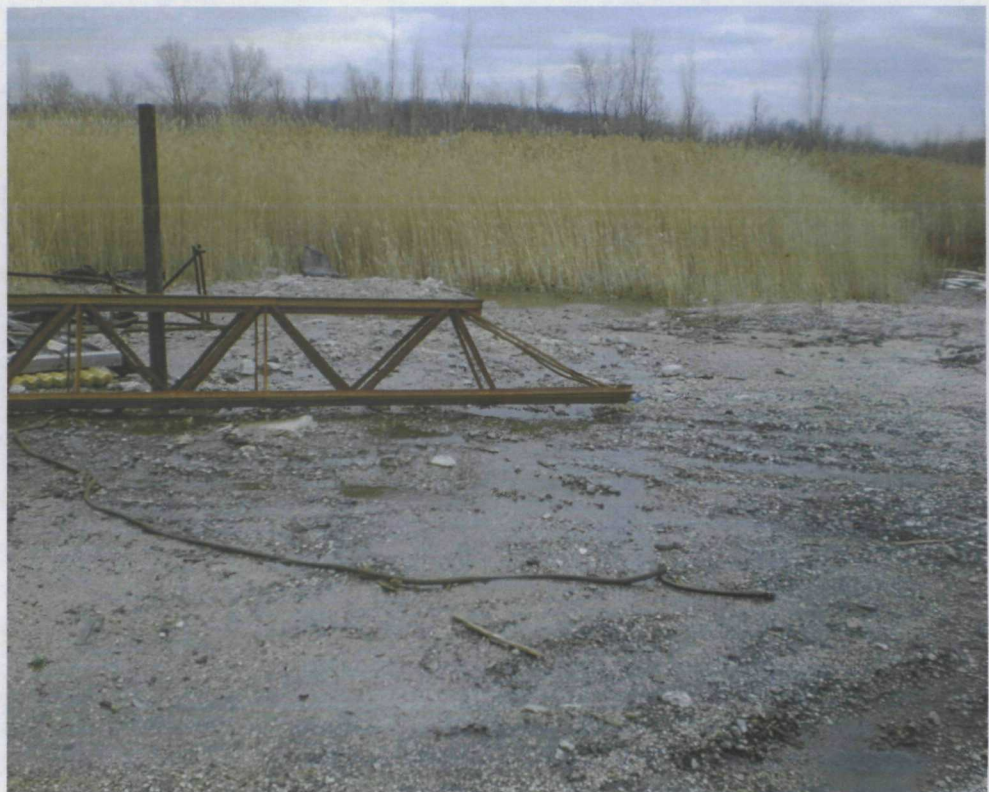
COMMENTS: Photo taken of surface water flowing on the surface of the slag parking lot. Water is ponded near the base of the reeds in the background.

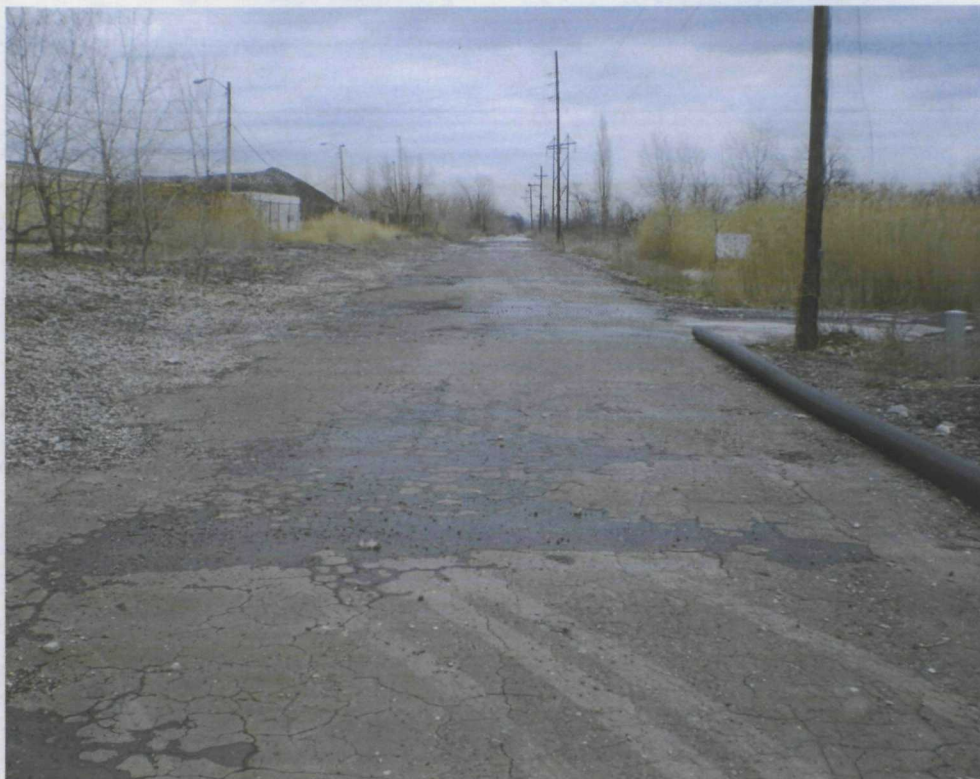
COMMENTS: Photo taken of Chemetco Lane and the ground water seeping through the cracks in the asphalt to the surface. This surface water then would flow to the south.

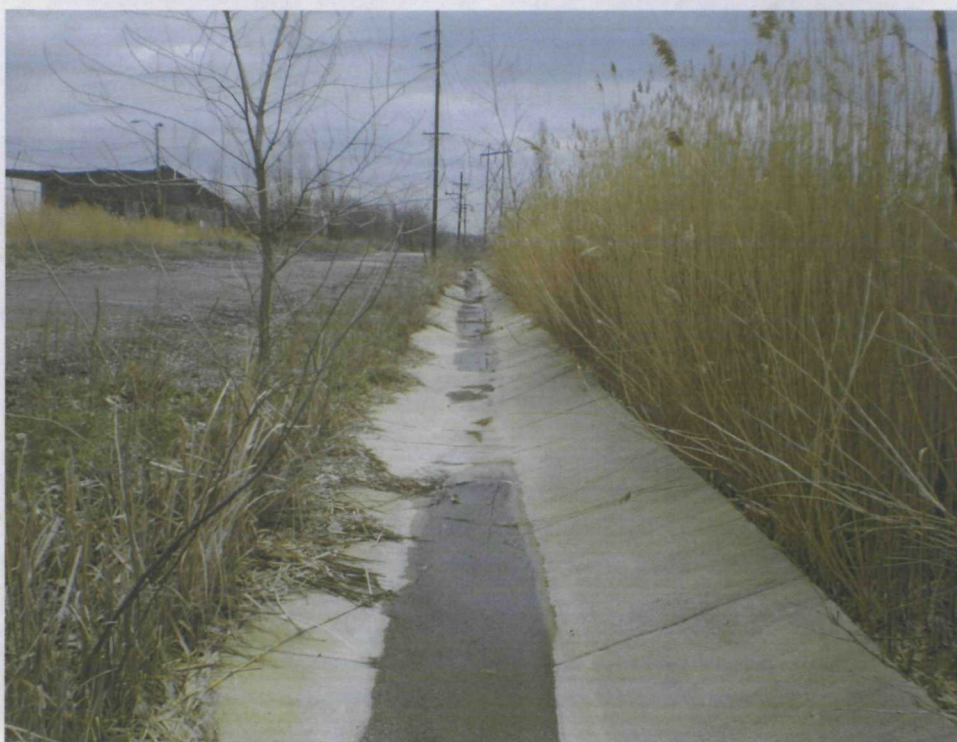
COMMENTS: Photo taken of the concrete lined ditch and the water which seeps into the ditch. This ditch directs water to a black pipe and then to a water holding basin.

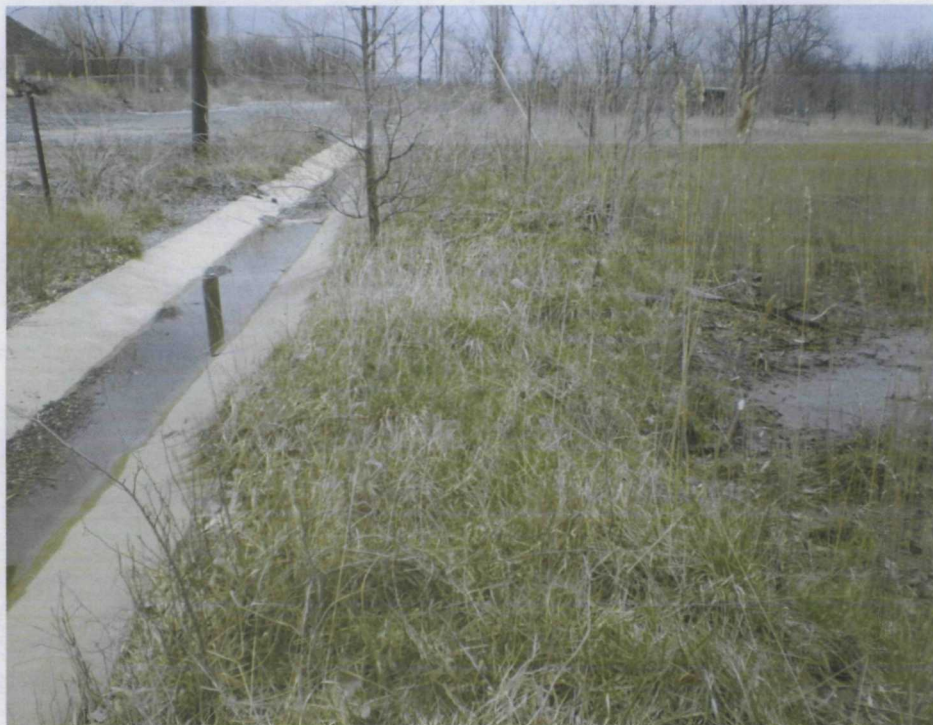
COMMENTS: Photo taken of the concrete ditch and of the area to the south of the ditch showing bare soil. This bare soil had ground water seeping to the surface and flowing south to the reeds which are wetlands.

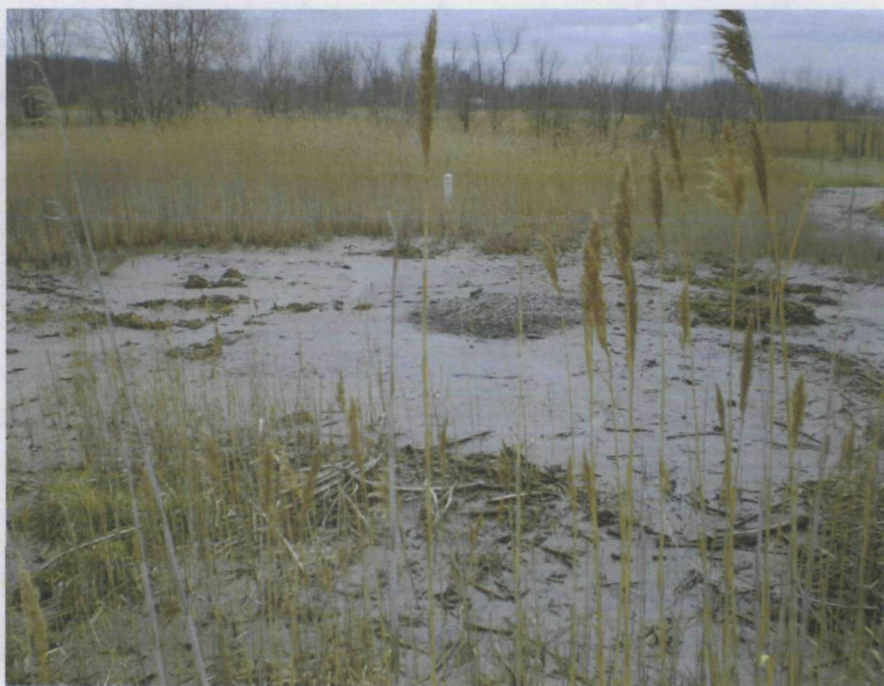
COMMENTS: Photo taken of the bare area of soil located to the south of Chemetco. This area was the location of the perched shallow aquifer. In the past it is suspected that the acid pits contributed to the contamination of this area.

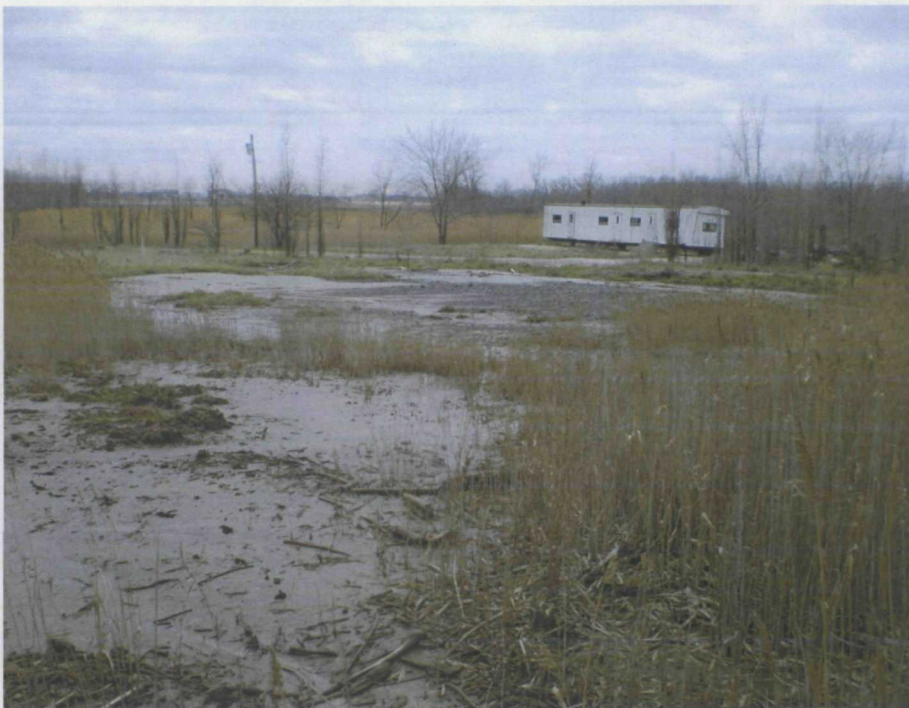
COMMENTS: Photo taken of the bare area to the south of Chemetco.

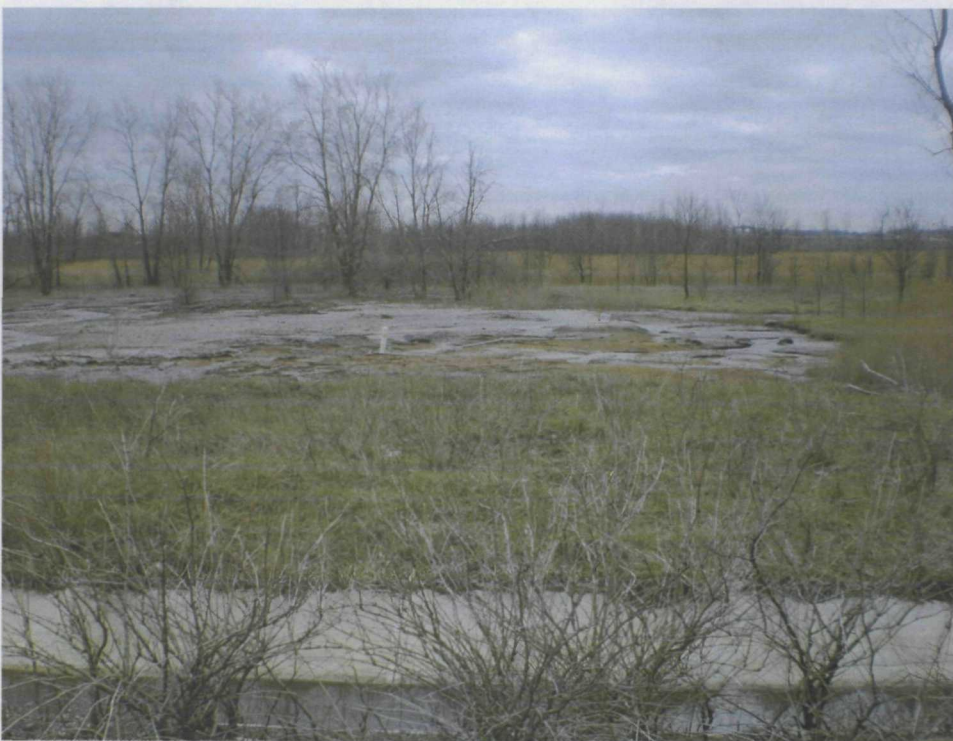
COMMENTS: Photo taken of the eastern bare area.

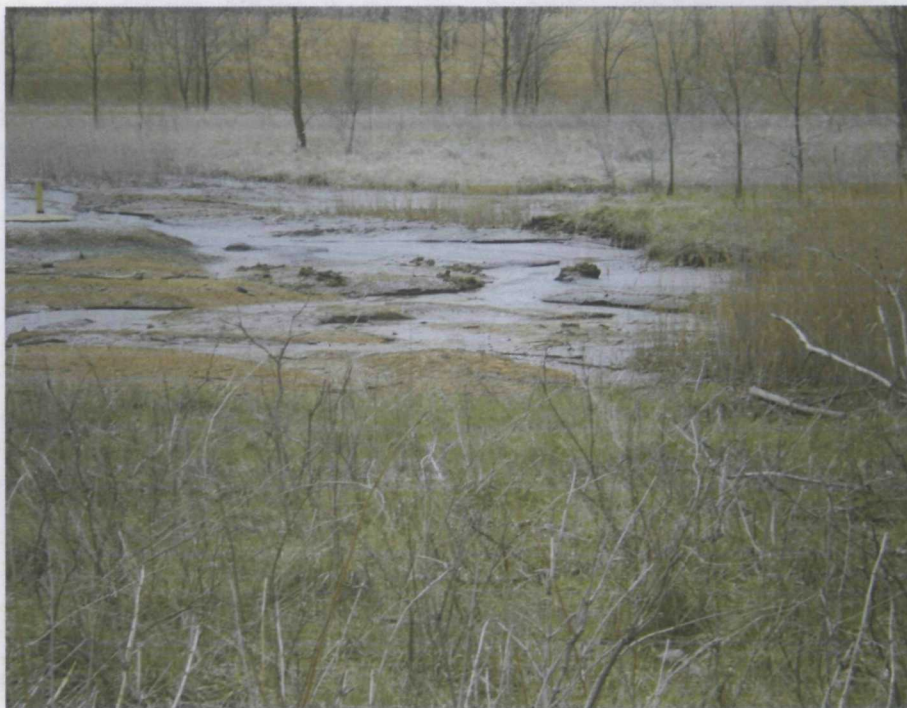
Picture taken of the drainage through the suspected acid spill area. No vegetation was growing in this area.

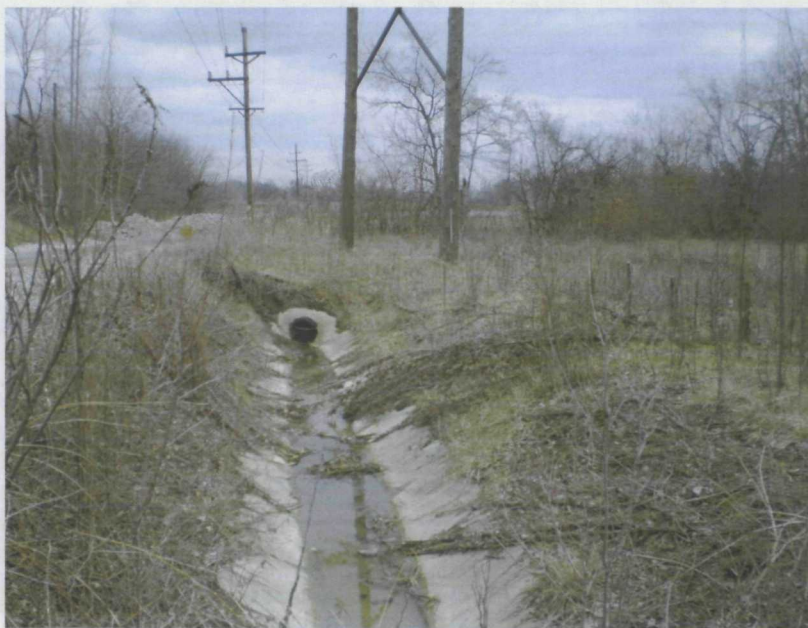
COMMENTS: Photo taken of the concrete lined ditch with water flowing to the east. This is part of the surface water control system. Water is directed to a holding basin to the east.

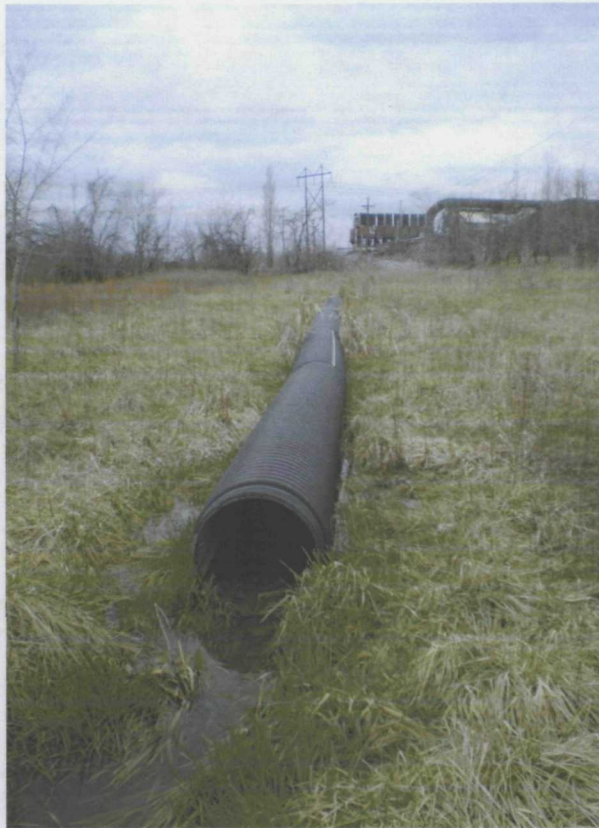
COMMENTS: Photo taken of the plastic pipe which directs surface water runoff to the holding basin.

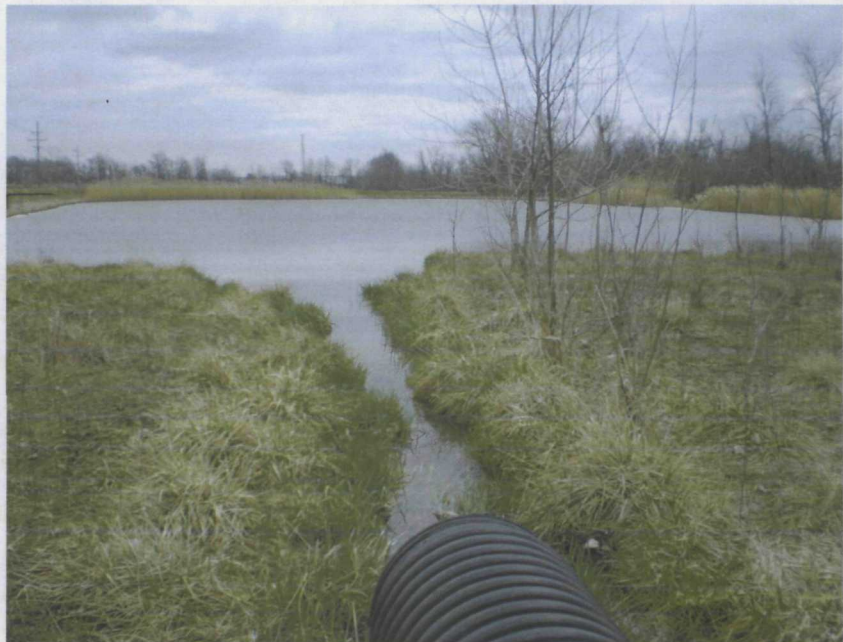
COMMENTS: Picture taken of the surface water holding basin.

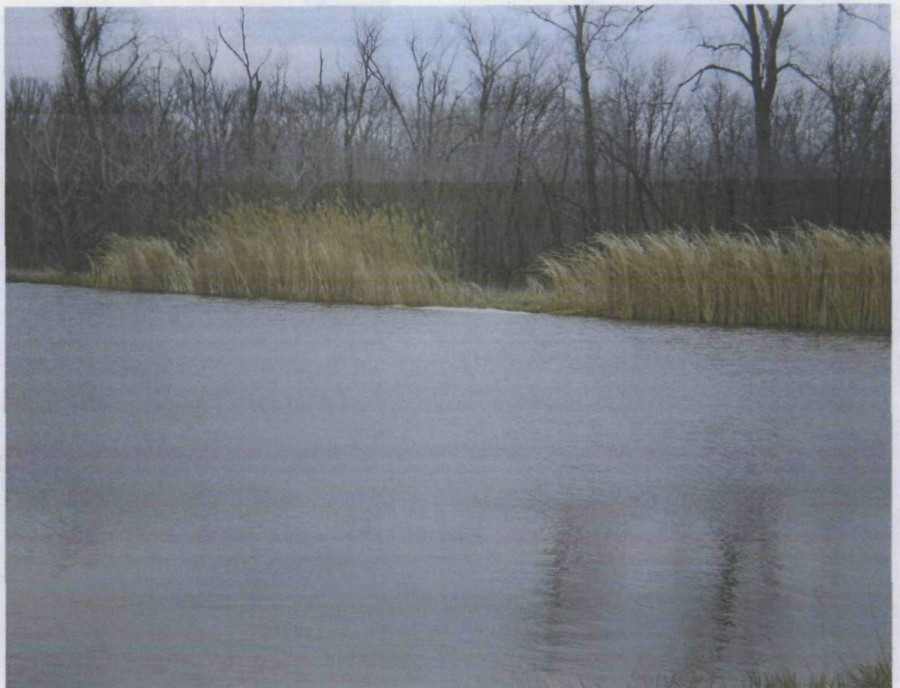
COMMENTS: Photo taken of the dam of the holding basin located on the south side. The area just to the right of the break in reeds is an area in which water was overflowing the dam.

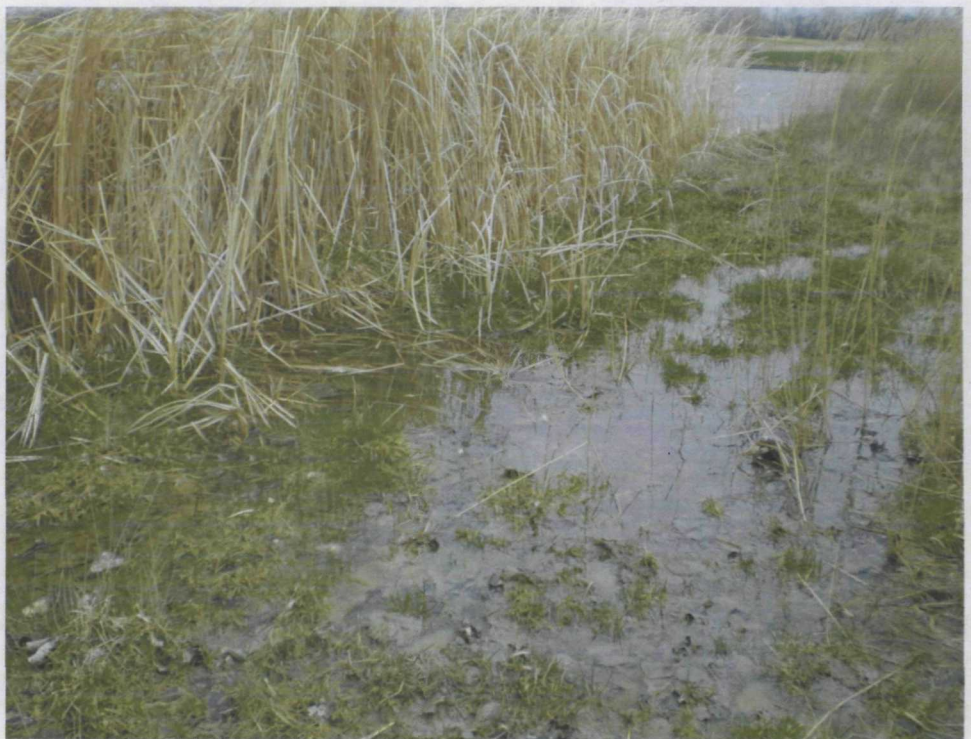
COMMENTS: Photo taken of the water which was overflowing the dam of the holding basin. Water was flowing south towards the wetlands and unnamed tributary of Long Lake.

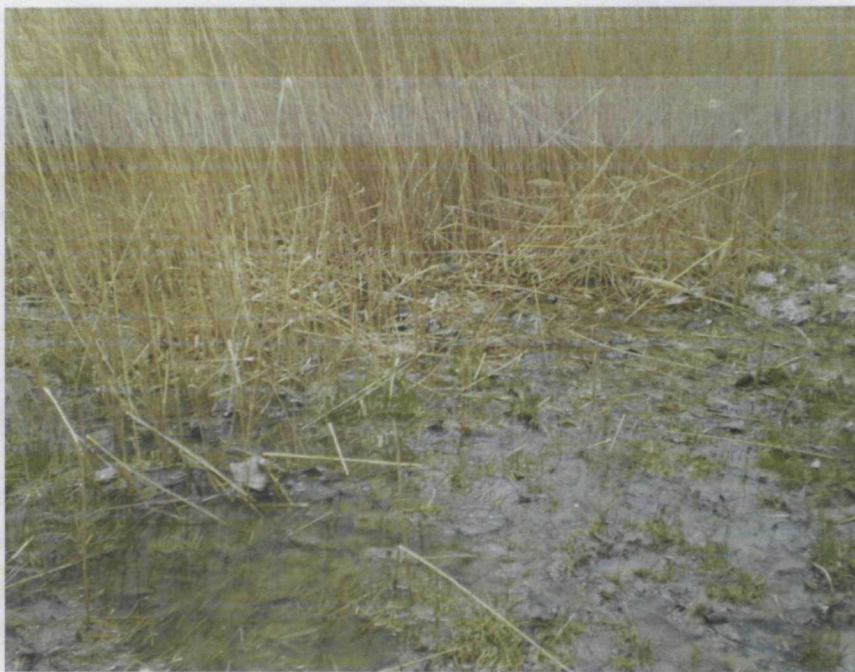
Another photo taken of the water overflowing the dam of the holding basin.

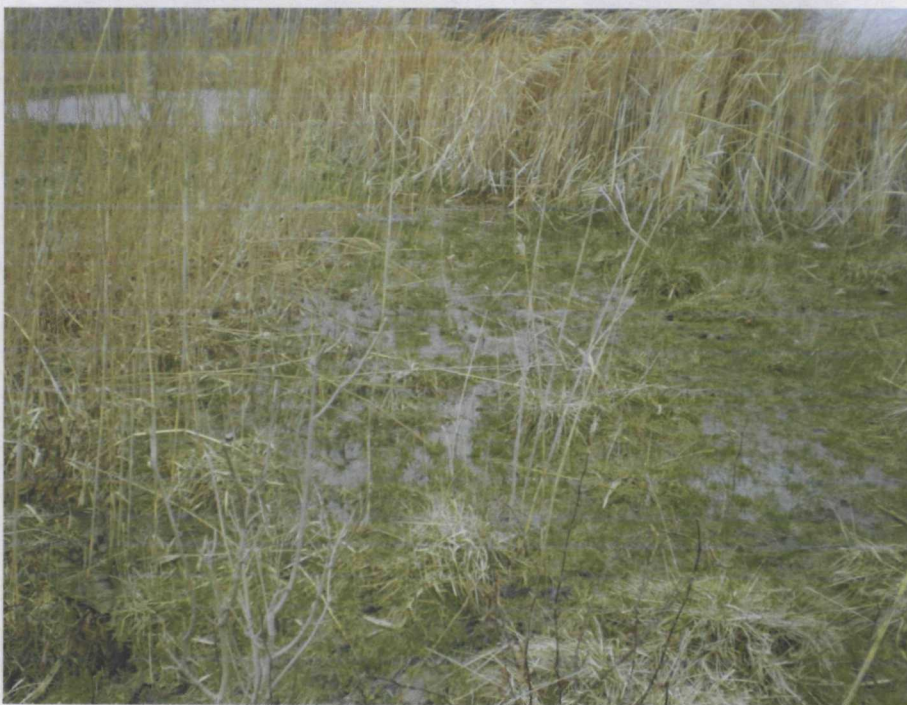
COMMENTS: Photo taken of the overflowing water from the holding basin. The water is flowing south. The holding basin is in the background.

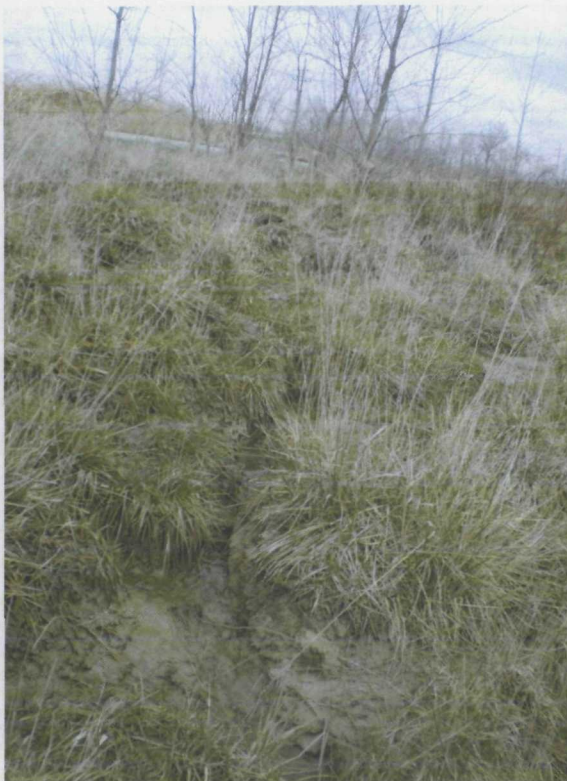
COMMENTS: Photo taken of the water overflowing the holding basin. This gulley was directing water to the south towards the wetlands and the unnamed tributary of Long Lake.

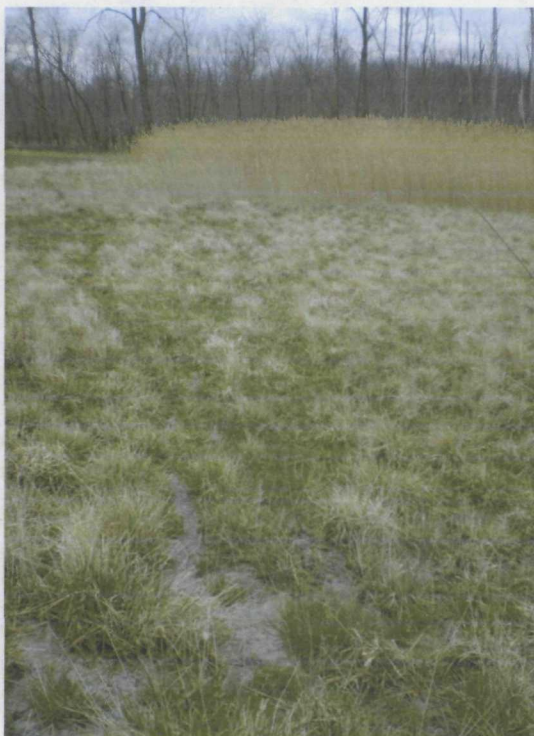
COMMENTS: Another photo of the water flowing south from the holding basin towards the wetlands located adjacent to the unnamed tributary.

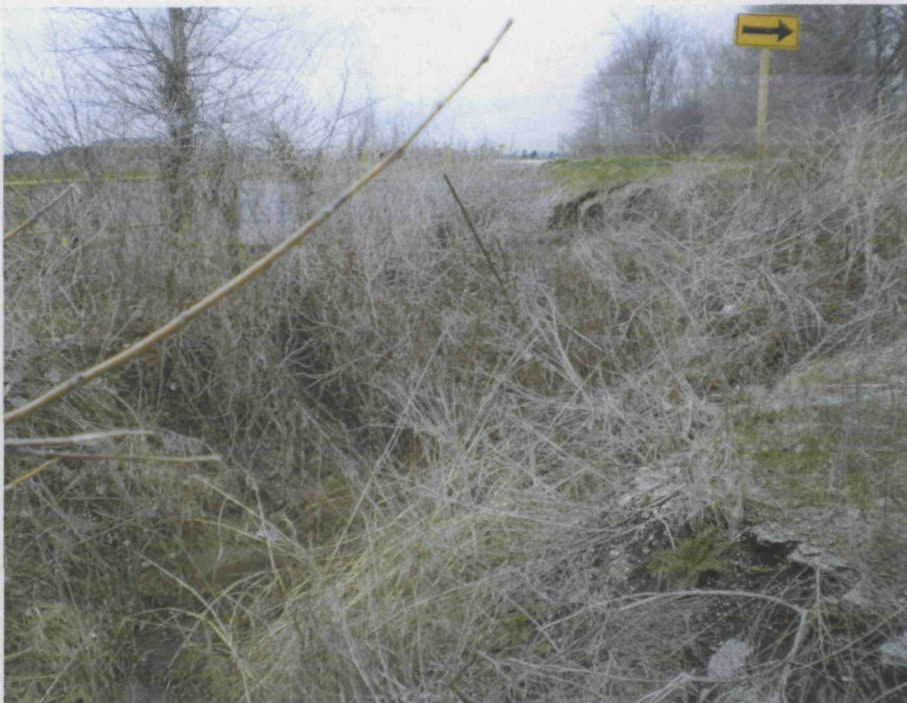
COMMENTS: Photo taken of the drainage ditch located to the east of Chemetco along New Poag Road. It was suspected that any runoff from the site might flow to the north and follow the ditch around the field to this location, but this was unverified.

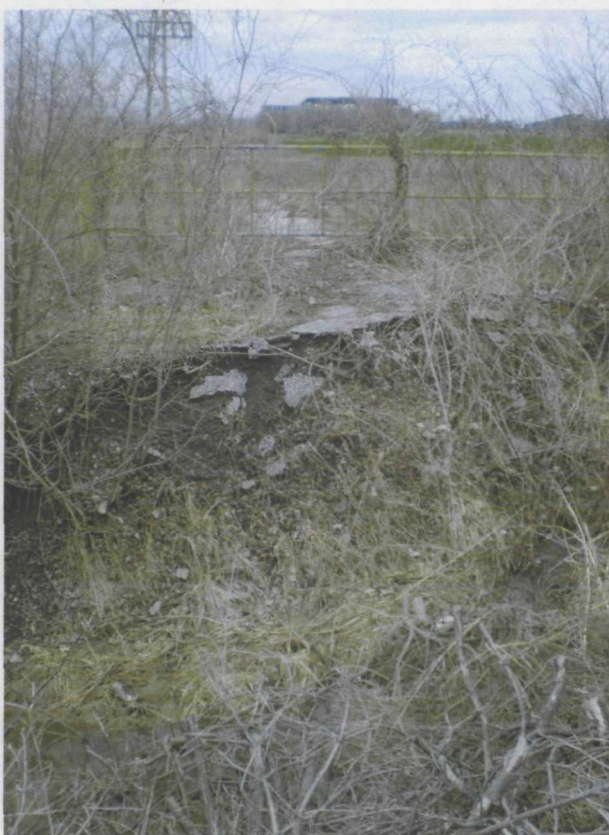
COMMENTS: Another photo taken of the ditch located to the east of Chemetco. Suspected drainage pathway for surface water.

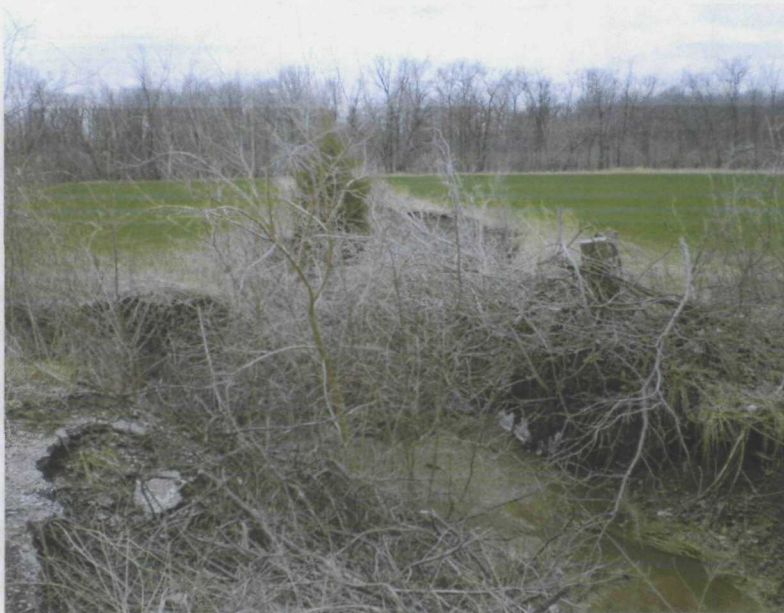
Another photo taken of the ditch to the east of Chemetco. This photo depicts the drainage to the south towards the unnamed tributary.

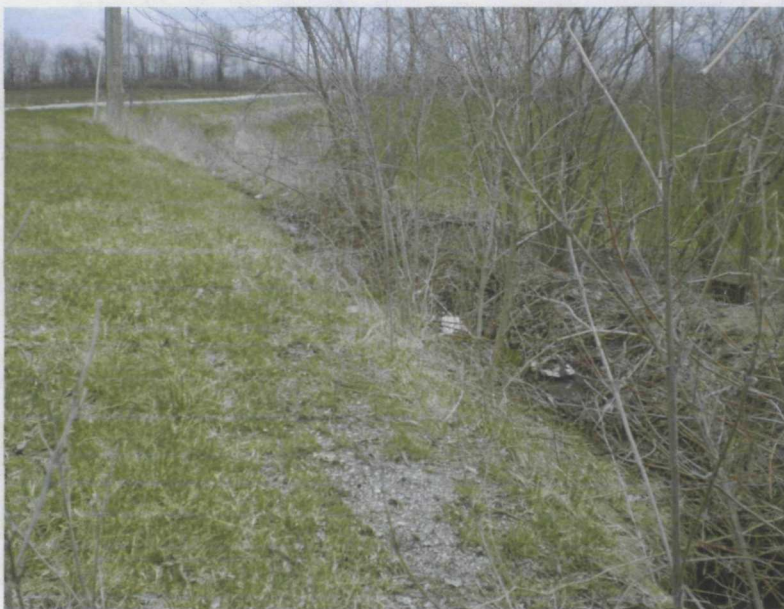
COMMENTS: Photo depicts the drainage from the east which would be flowing into the east drainage ditch depicted in the above photo.
